GLULAM CONNECTION DETAILS

Introduction

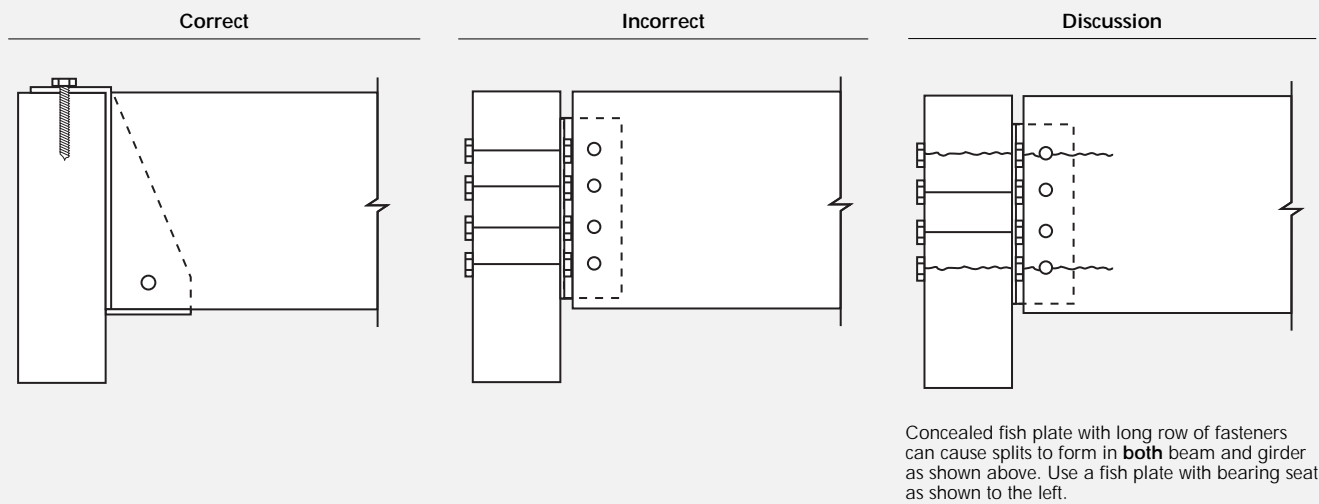
FIGURE 7

BEAM-TO-BEAM CONNECTIONS – SEMI-CONCEALED USING FISH PLATES

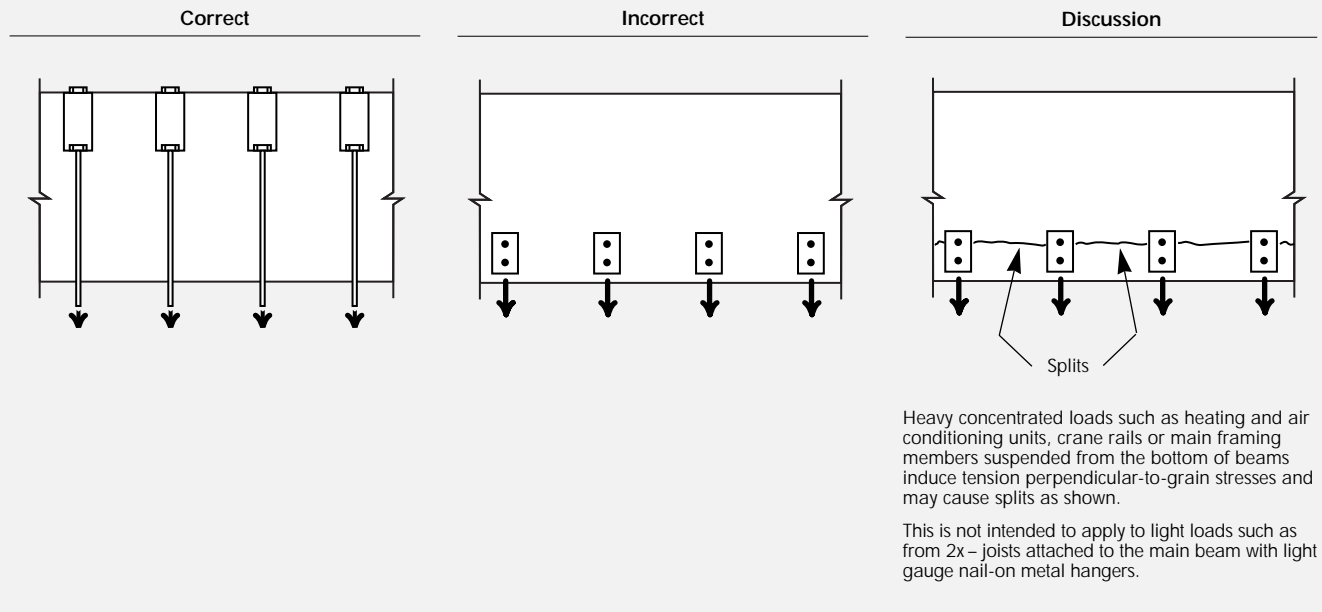
FIGURE 8

HEAVY CONCENTRATED LOADS SUSPENDED FROM BEAM
